PASSAIC RIVER BASIN
WHIPPANY RIVER, MORRIS COUNTY
NEW JERSEY

POCAHONTAS DAM

NJ 00360

PHASE 1 INSPECTION REPORT
NATIONAL DAM SAFETY PROGRAM

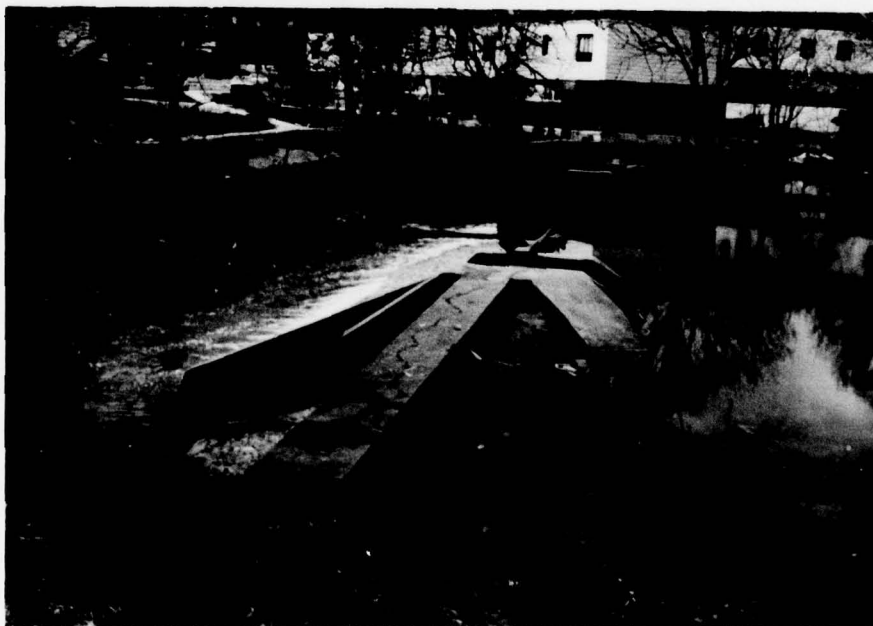
The general condition of the concrete wall surfaces of the dam appeared to be good. The training walls, overflow section and east wall section appear to be aligned true to the construction drawings. Some surface cracks were observed in the east and west training walls. A surface crack was also observed in the concrete wall section forming the east end of the dam.

PHOTO 2
CREST OF DAM AND SPILLWAY

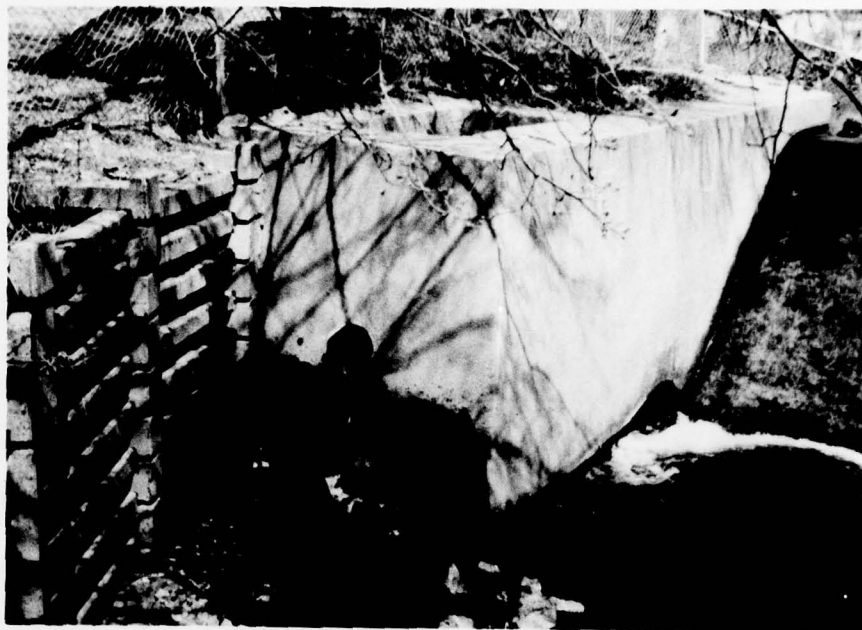
PHOTO 3

WEST TRAINING WALL FOR SPILLWAY

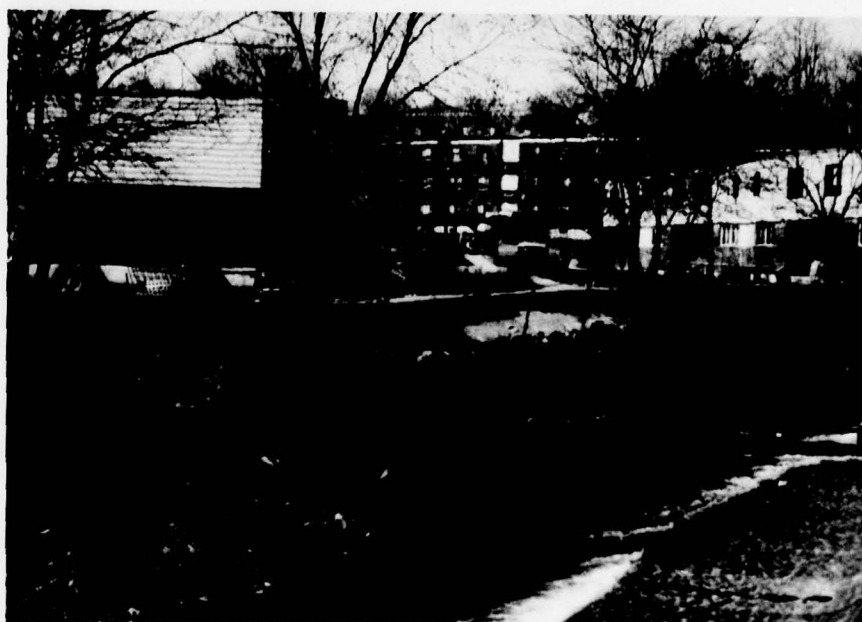
PHOTO 4

A chain-link fence is located along the eastern bank of the lake and along the downstream channel. In the area immediately downstream from the dam, the fence post foundations are undermined causing instability in several sections of the fence. The remainder of the fence appeared to be in satisfactory condition.

A concrete cribwall extends downstream from the west end of the dam. Forming the side wall of a spillway discharge channel, the cribwall protects the downstream bank and directs discharge from the west end of the dam into the downstream channel. The cribwall appeared to be intact structurally. However, fill behind the cribwall was inadequate and undermining of the fence post foundations was apparent.

CRIBWALL BANK PROTECTION DOWNSTREAM OF SPILLWAY

- 2) The eroded area at the east end of the dam should be filled and stabilized.
- 3) The concrete cribwall should be backfilled with suitable material and stabilized.
- 4) The chain-link fence on the west side of the dam should be repaired.
- 5) Debris accumulated on the downstream side of the spillway and on the spillway crest should be removed.
- 6) The concrete spillway should be thoroughly inspected and renovated as outlined below:
 - a. Drain the lake to an elevation equal to the invert of the lift gate.
 - b. Thoroughly inspect and sand blast all concrete.
 - c. Pressure grout all major cracks and patch all spalls and deteriorated surfaces.
 - d. Apply an epoxy preservative coating to all surfaces.
- 7) The scoured channel bottom immediately downstream from the spillway apron should be filled and suitably stabilized.

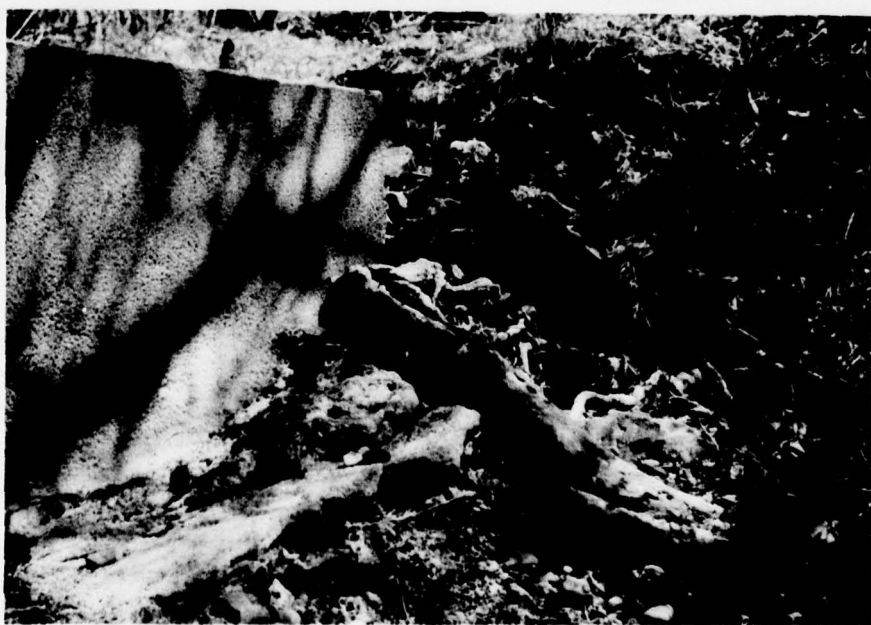
PHOTO 6
JUNCTION BETWEEN EAST END OF DAM AND BANK
